The Smith Creek Restoration Project: Summary Report 2009

Case History: Smith Creek

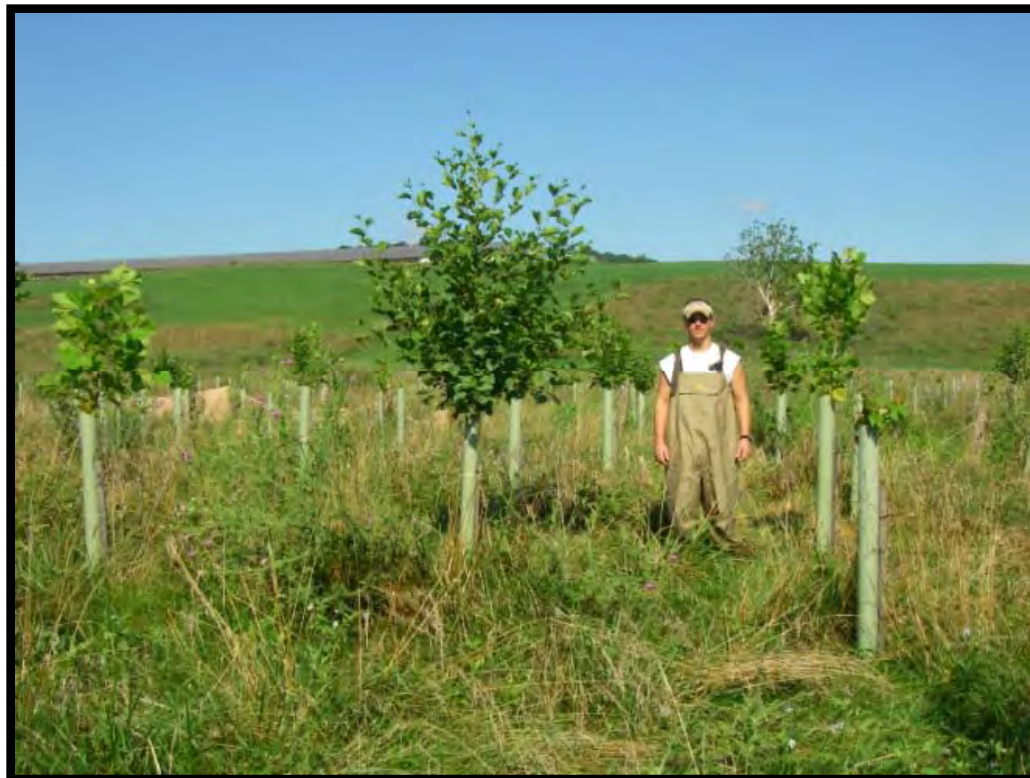
In 2005 : 65 acres of the floodplain were planted with a total of 12,561 saplings (Seven different species: white ash, northern red oak white oak, hackberry, red maple, smooth alder American sycamore).

Sapling survival through 2008 has been estimated at 70% but varied by species.

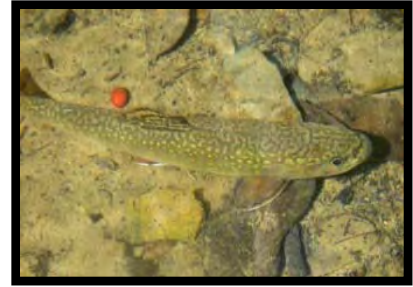
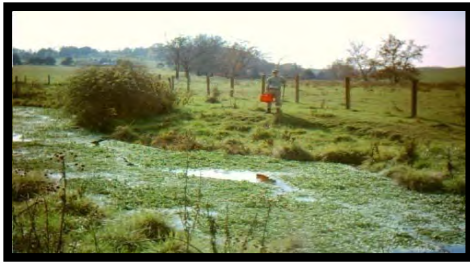
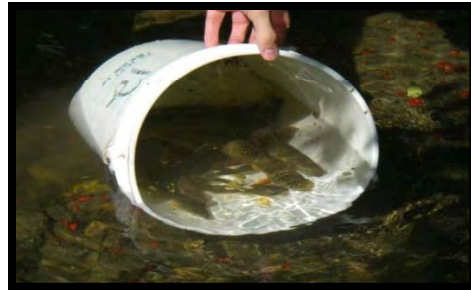
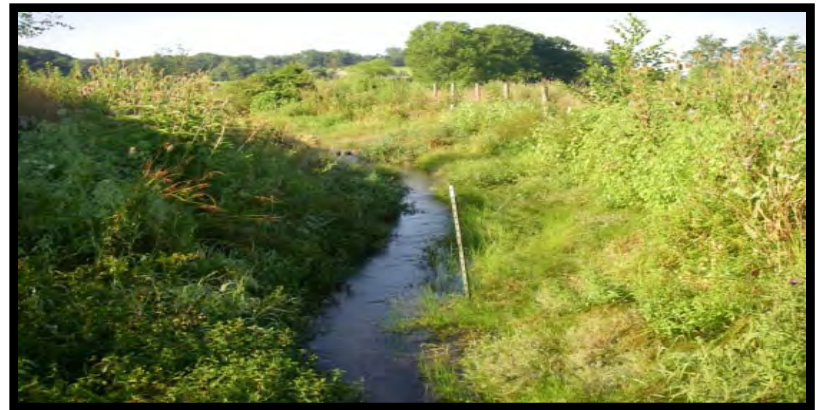
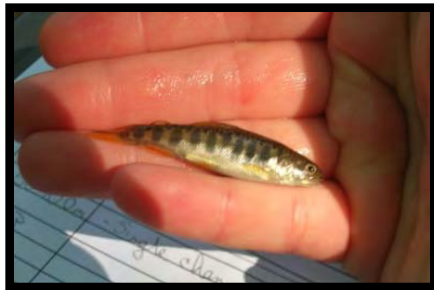
Spring Restoration

- 180 m spring creek restored in 2006
- Added logs and boulders
 - Plunge pools and overhead cover
- Narrowed stream channel
- Stocked with adult brook trout
 - Successful reproduction documented yearly
 - Spring creek now holds brook trout year round
